Manhole Inspection Summary

Manhole # S47K__037MH

Insp Date: **2/25/09 9:46 AM**

Location Address: **2051 fleet st**

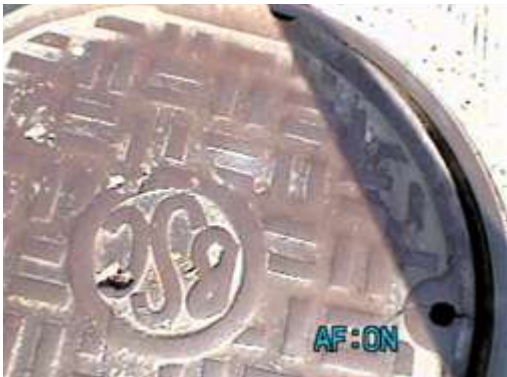
Defect 5

Type: **Sanitary** Condition: **Cracked** Cover Material: **Cast Iron**

crack cover

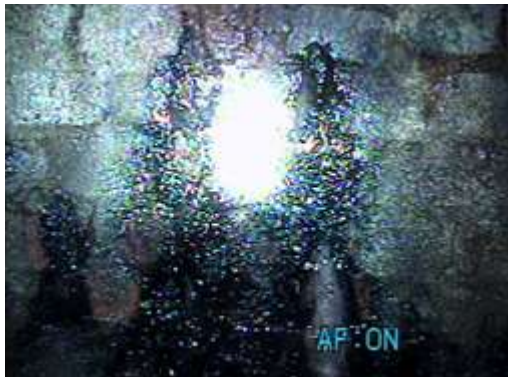
Defect 4

Infiltration: ☐ None ☐ Joint ☐ Cracks ☐ Mortar ☐ Roots ☒ **Wall**

barrel infiltration

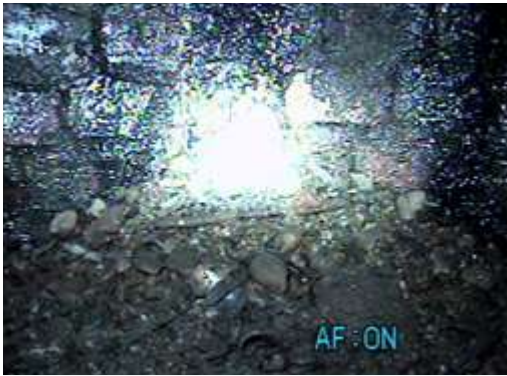
Defect 3

Condition: ☐ Sound ☐ Cracked ☐ Root Intrusion ☐ Deteriorated ☐ Leaks ☒ **Debris**

bench debris

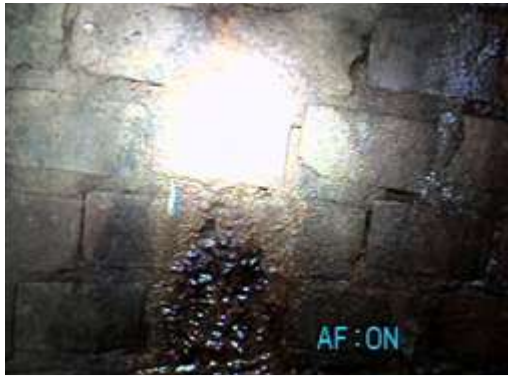
Defect 2

barrel infiltration

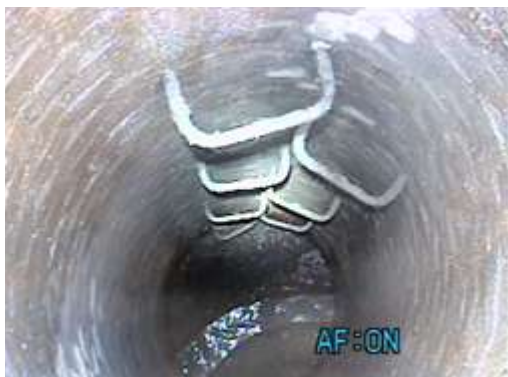
Defect 1

Steps Count: **7** Missing: **0** ☒ **Corroded**

cor steps
